LANDSLIDES AND RELATED FEATURES

OF THE WORTHINGTON, PA. QUADRANGLE

by
John S. Pomeroy
1979

U.S. Geological Survey
OPEN FILE MAP 79-1314 (G-3)

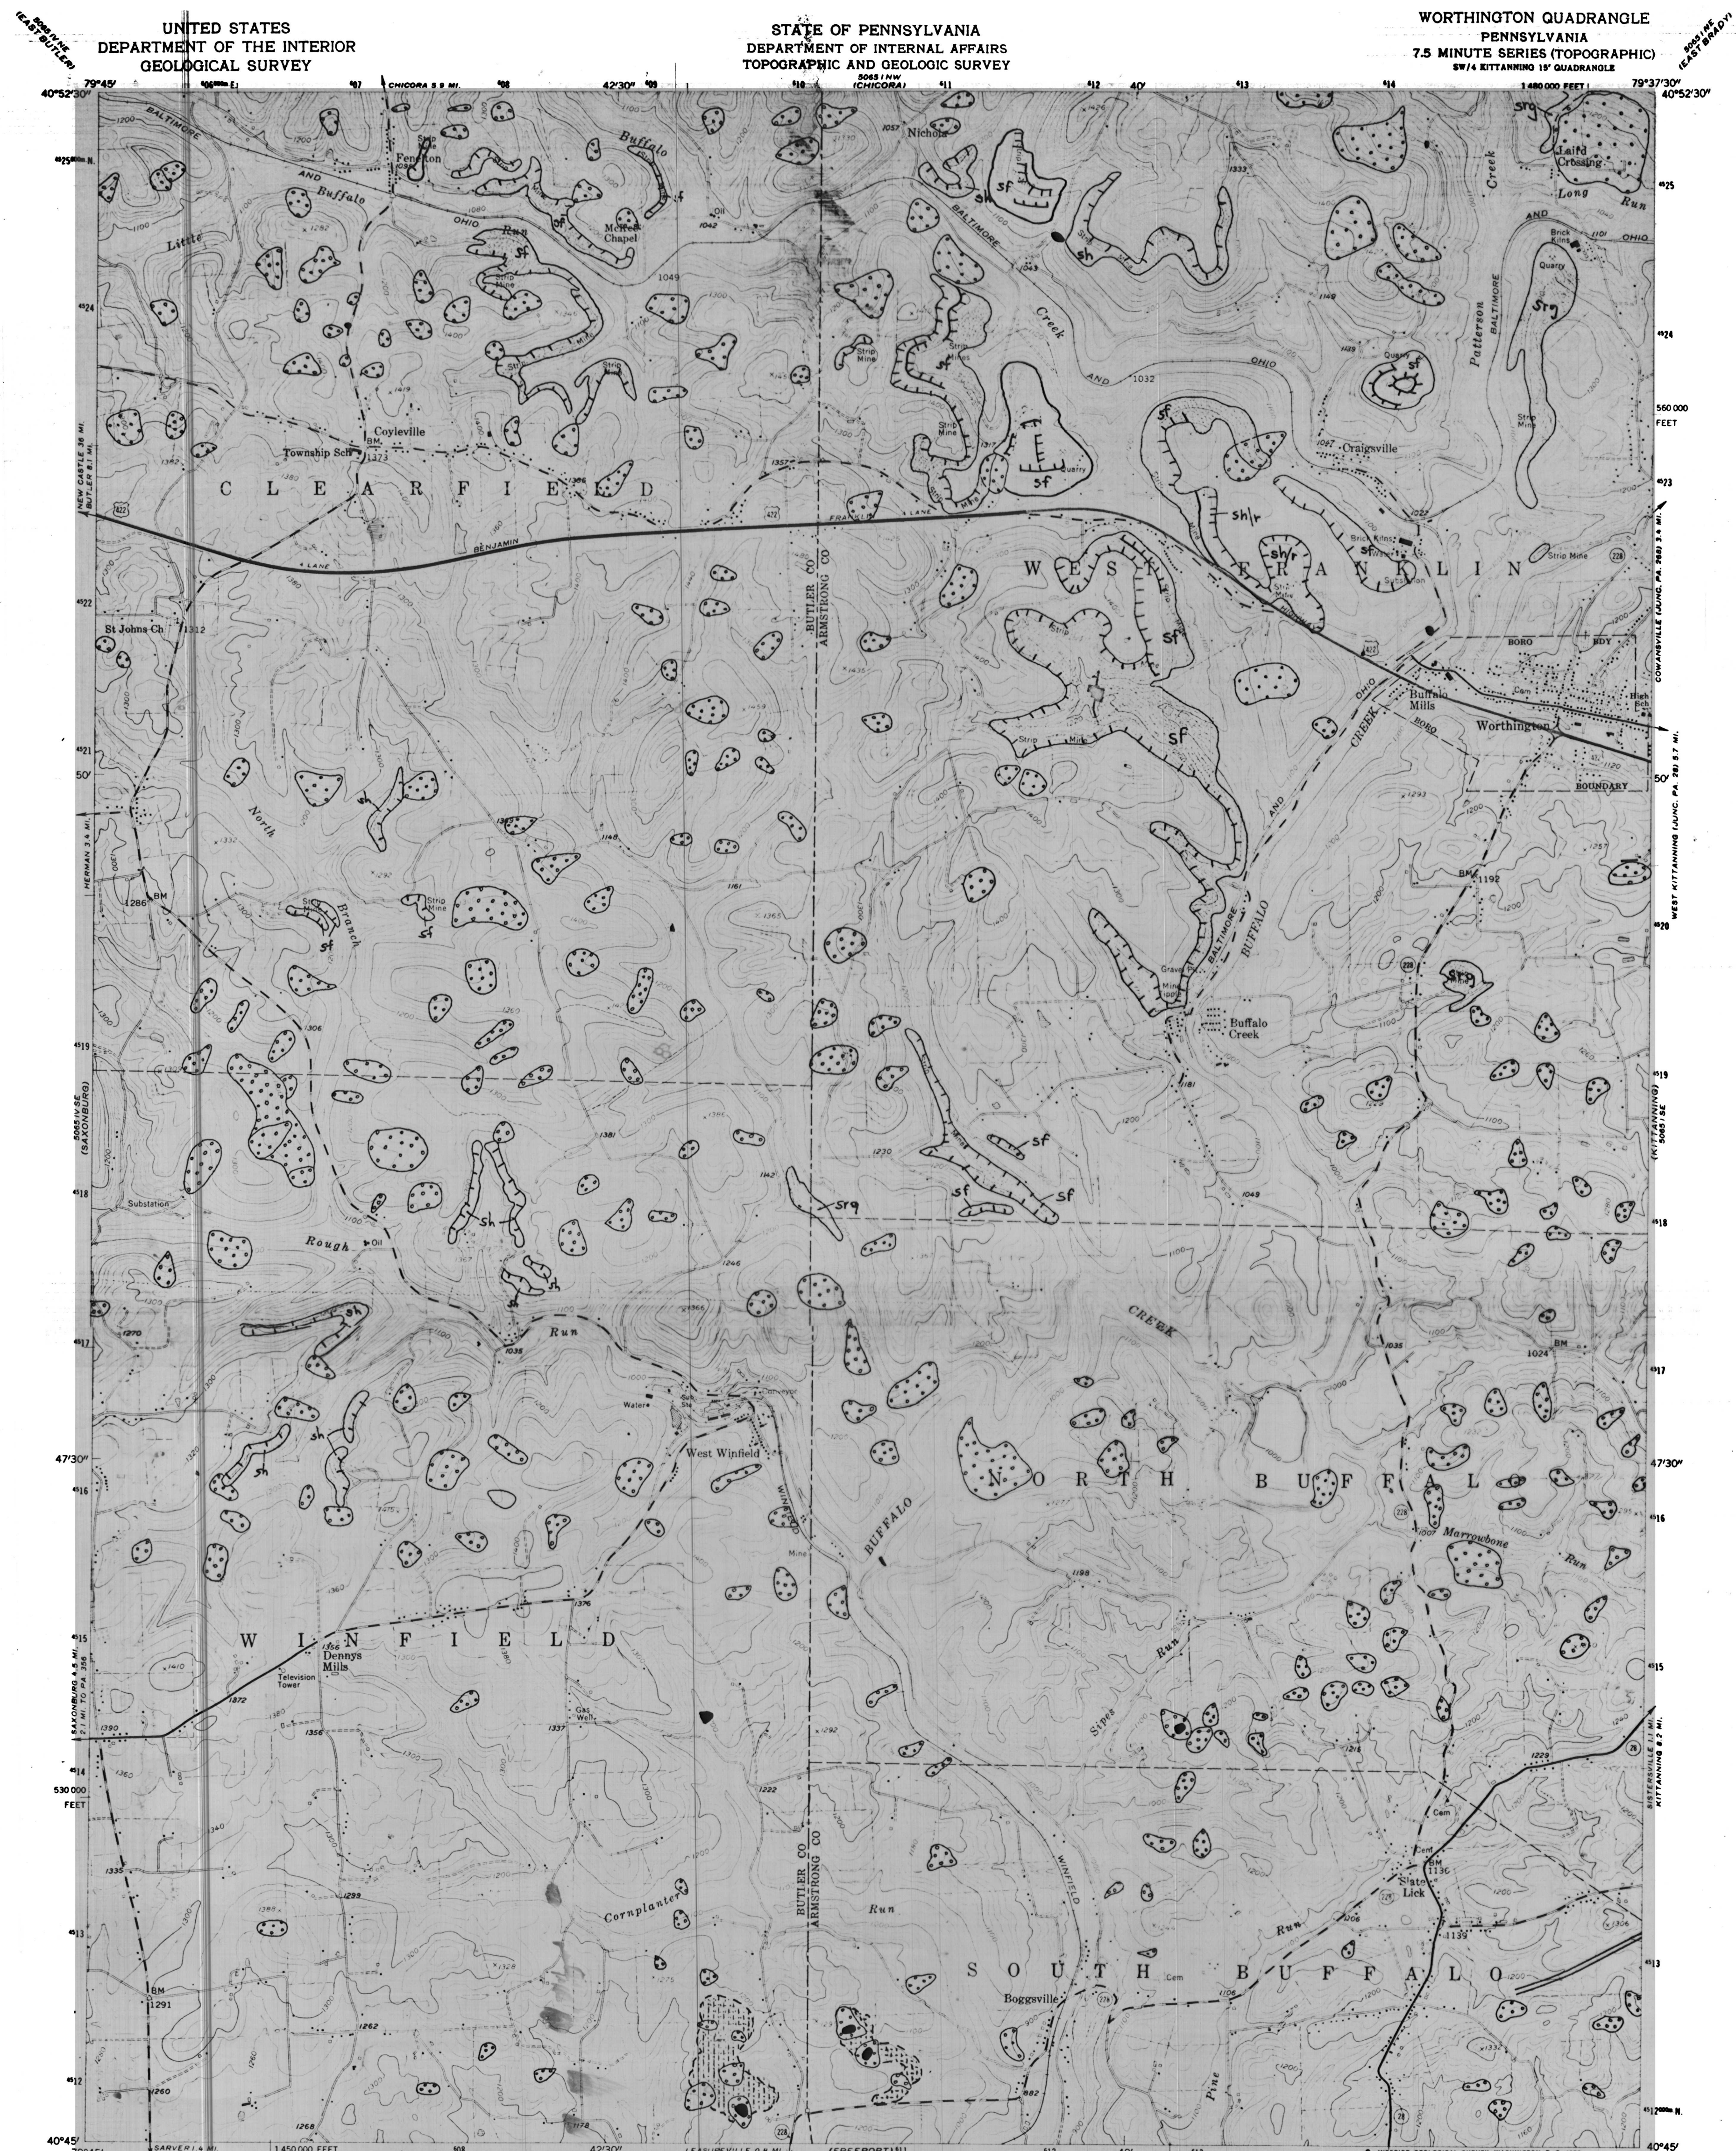
WORTHINGTON, PA.
SW 1/4 RITTANNING 19' QUADRANGLE
N 4045—W 7937/5/7.5
1958
PHOTOREVISED 1969

ACTIVE OR RECENTLY ACTIVE LANDSLIDE

Complex landslide composed of earthflow, debris slide, earth and rock slump. Identified from historical records, and from scars, debris and other field evidence. Ground extremely unstable; sliding accelerated by excavation, loading and changes in drainage conditions. May include areas with several active slides too small to be shown separately. Questioned where doubtful.

OLD LANDSLIDE

Area of extensive hummocky ground caused by earthflow and earth and rock slump. Lacks clear evidence of active sliding. Relatively stable in natural, undisturbed state, generally not affected by small structures properly sited in areas away from the edge of the toe; can be reactivated by extensive, rapid excavation, loading, and changes in ground water and surface water conditions. Area of old landslide probably includes recent ones not identified from field evidence or otherwise documented. Upslope boundary of landslide generally defined by modified scarp, but downslope (toe) may be gradational and not well defined. Questioned where doubtful.

COMBINATION LANDSLIDE

Area of recent and old slides in which individual slides are not identified.

COLLUVIAL SLOPE

Valley wall along major streams with slope as steep as 40° (85%); stony, clayey silt soil up to 50 ft. (15 m) thick; commonly buttressed by a terrace or bench at the toe of the slope; very susceptible to sliding by cutting of toe area, removal of terrace or bench, and overloading; slide commonly activated without apparent cause.

AREAS SUSCEPTIBLE TO DEBRIS FLOWS AND DEBRIS AVALANCHES

Primarily shallow, narrow ravines and chutes with accumulation of stony colluvium generally 10 ft. (3 m) or less in thickness; susceptible to rapid movement during intense rainfall. Most ravines and chutes designated show evidence of former debris flows and avalanches. Symbol & designates historical debris flow or debris avalanche.

AREAS SUSCEPTIBLE TO ROCKFALL

Steep, locally vertical, natural and man-made slopes and cliffs, 15 ft. (4.5 m) or more high; formed dominantly of sandstone, limestone, sandy shale, mudstone and claystone. Interbedded mudstone, claystone and shale weather rapidly leaving sandstone and limestone rock faces unsupported.

SOIL AND ROCK SUSCEPTIBLE TO LANDSLIDING

Soil and rock similar to that involved in landslides elsewhere in map area; primarily areas underlain by claystone, mudstone and shale associated with other rock types. Rock weathers rapidly on exposure forming clayey soil highly susceptible to sliding. Includes coves (U-shaped, shallow valleys) containing thick layers of clayey soil that are very susceptible to sliding where excavation breaks continuity of slope and where overlaid by artificial fill.

Information shown is intended as a general guide to ground conditions as of the date of field check. Additional landslides and rockfalls should be anticipated in all map units. The map unit depicts the dominant condition in the area delineated and variations in slope stability may occur at any point in the unit. This map is suitable for general planning purposes and as a supplement to more detailed studies for site selection. The map cannot be used as a substitute for detailed geologic and engineering investigations to establish design and construction criteria of specific sites. Some symbols may not appear on this map because the description is applicable to a series of maps.
